In re Flint Water Cases,
No. 16-cv-1044

Supplemental Report of Dr. Larry L. Russell

October 18, 2022

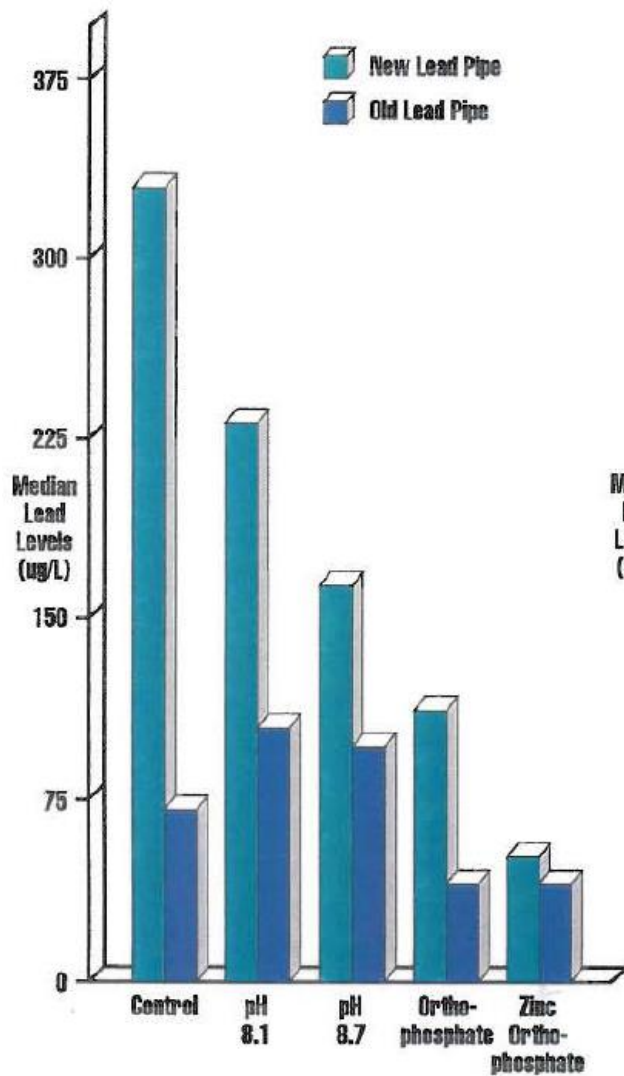
Figure ES-5
Relative Lead Levels from Lead Pipe

Figure 4.1-4: *DWSD Lead and Copper Corrosion Control Optimization Study (1994)*, Figure ES-5 and ES-6: Measured lead levels from lead pipe (left), brass and soldered copper pipe (right) during corrosion control optimization testing.

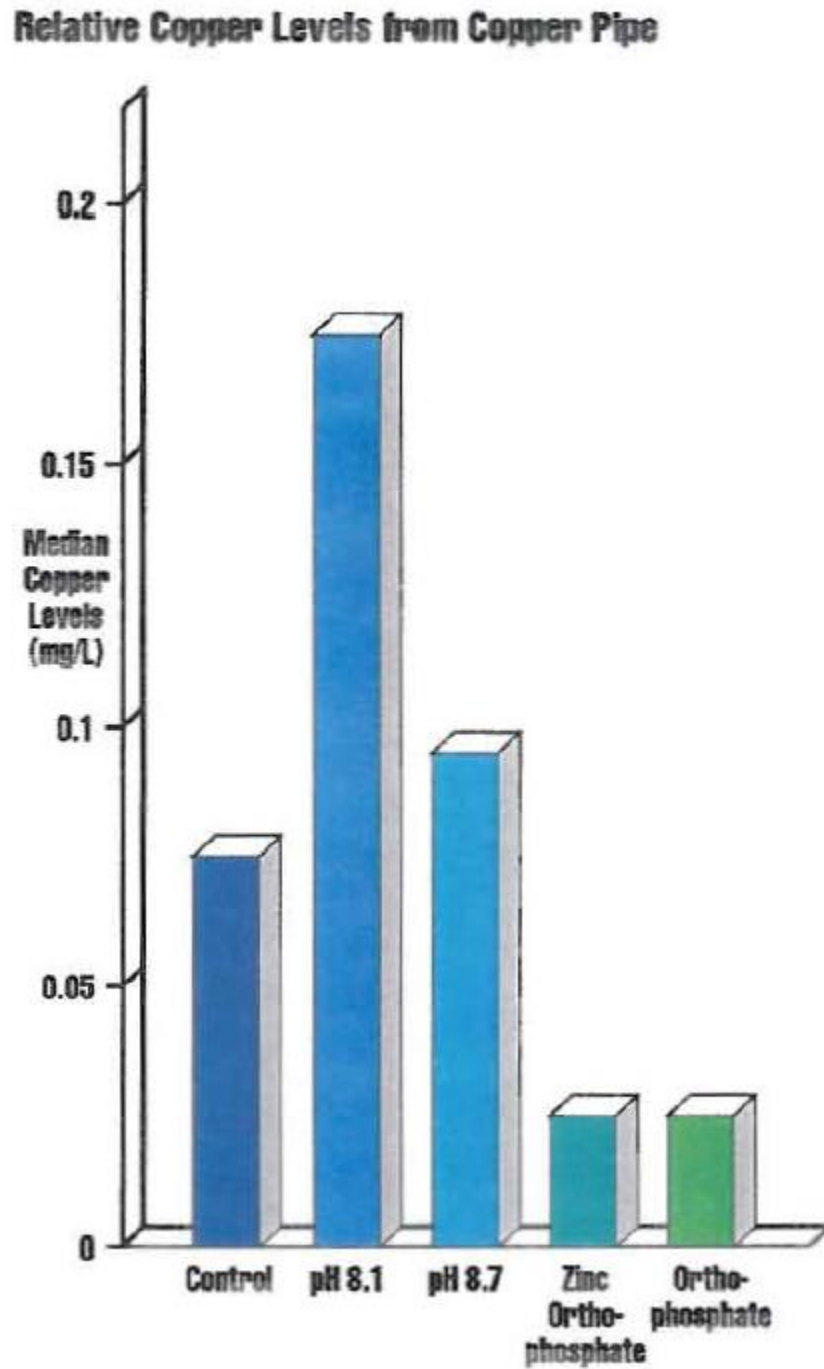
Figure 4.1.4 demonstrates the effectiveness of the chosen chemical addition, Orthophosphate, in controlling lead corrosion with the treated Lake Huron water. Figure 4.1.5 demonstrates the effectiveness of the chosen chemical addition, Orthophosphate in controlling copper corrosion with the treated Lake Huron water. After a substantial pipe loop testing of these alternatives, the TYJT team correctly recommended a treatment strategy using phosphoric acid to add orthophosphate at a recommended dose of 1.2 mg/L as P, initially, and reducing it to a sustained dosage of 0.4 mg/L, as the optimal DWSD corrosion control treatment in their 1994 study (ES-9).

Figure 4.1-5: *DWSD Lead and Copper Corrosion Control Optimization Study (1994)*, Figure ES-7: Measured copper levels from copper pipe during corrosion control optimization testing.

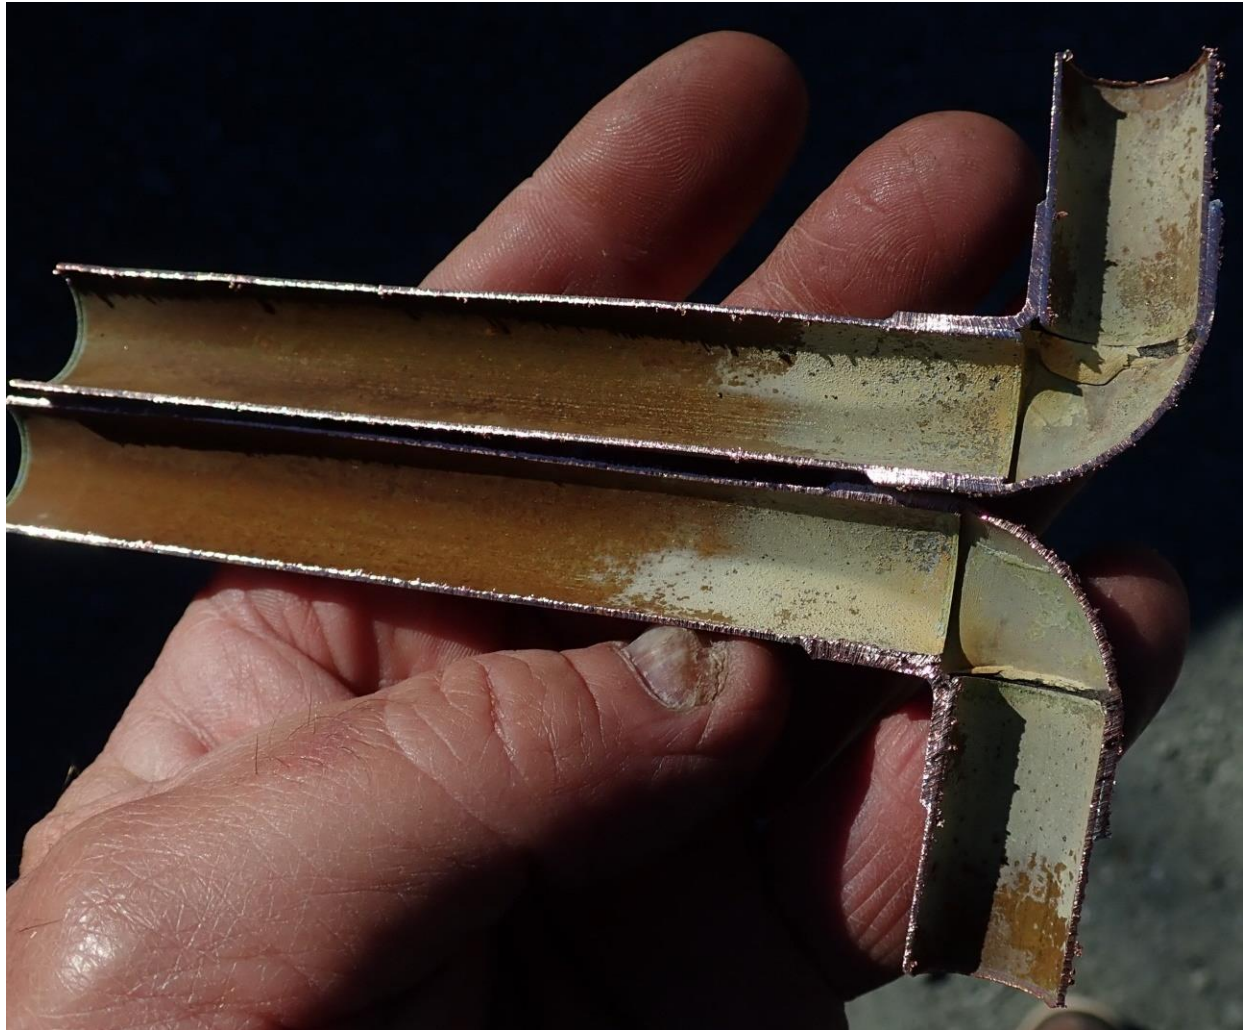
Figure 4.2-5: Pipe sample “F”, sectioned, close up

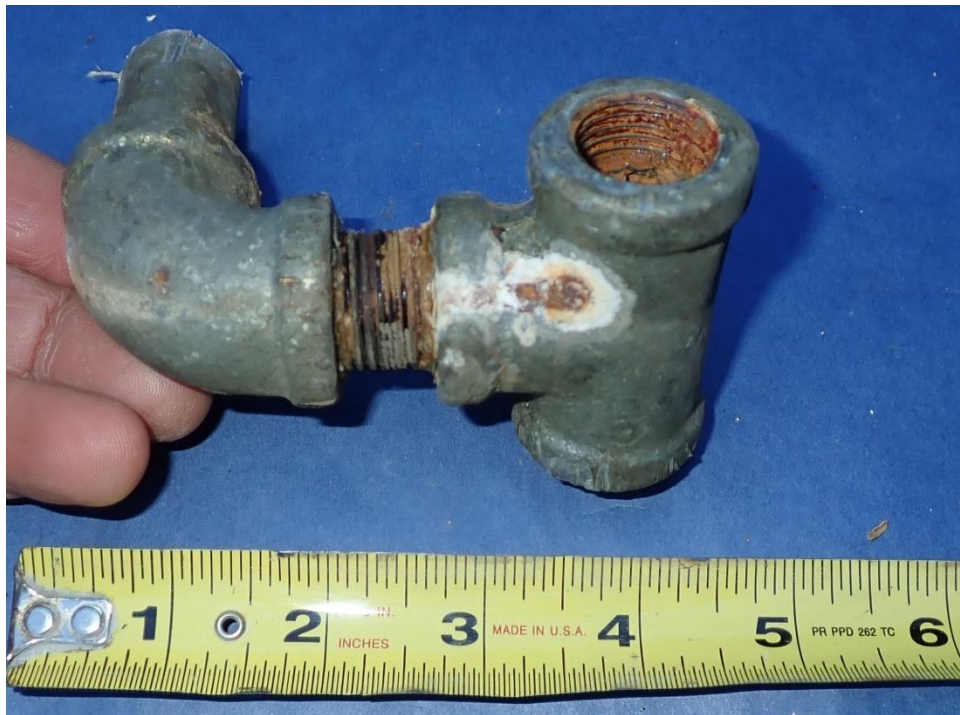
The steel pipe fittings were heavily tuberculated with iron oxide deposits. Under each tubercule is a pit that will penetrate the wall at some point in time (this had already occurred in samples labeled Flint G and H). The lead concentration in the scale on pipes G,H, I was 41.8, 168, 83.3 ppm, respectively, which are substantial lead concentrations that would be solubilized if the water became more corrosive (as it did during the Flint Water Crisis) and/or the corrosion inhibition program failed due to insufficient addition of chemicals.

Figure 4.2-6: Pipe sample “G”. Note the corrosion and scale present on the exterior of the tee indicative of a through wall leak.

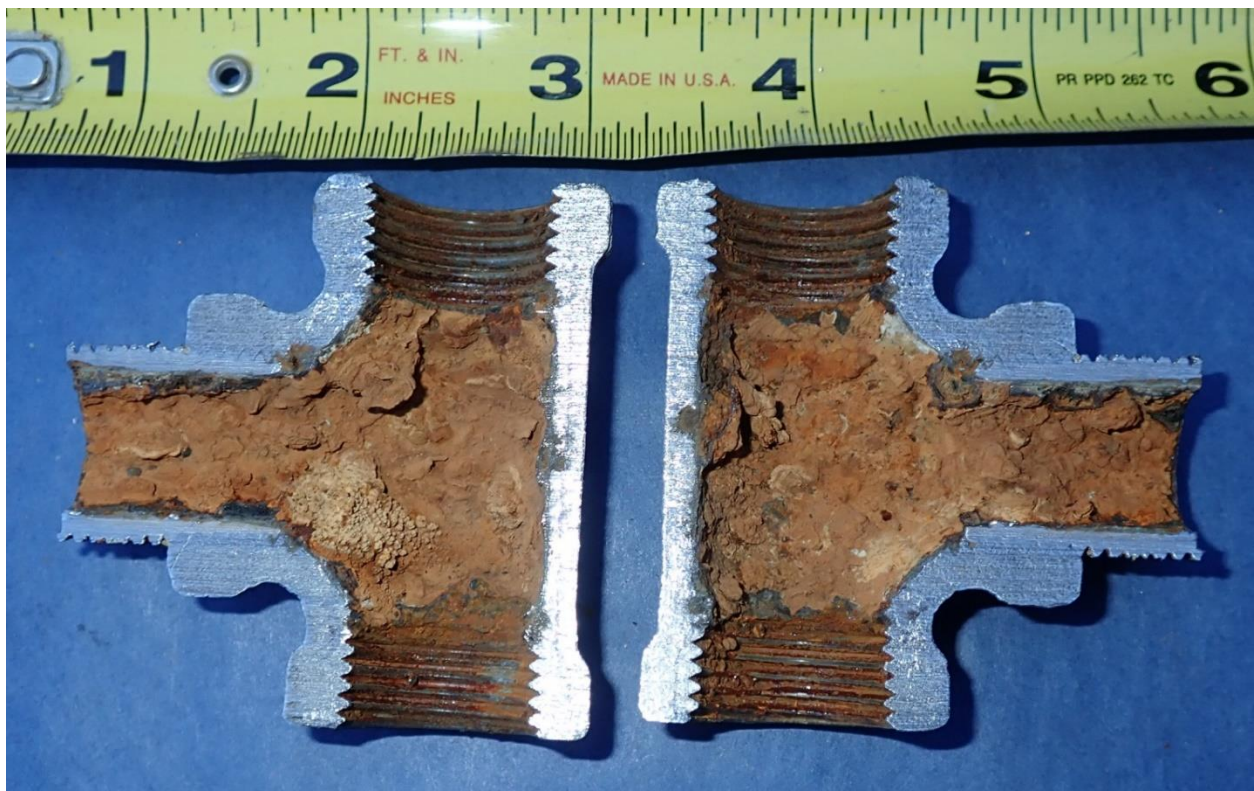
Figure 4.2-7: Pipe sample “G”, sectioned.

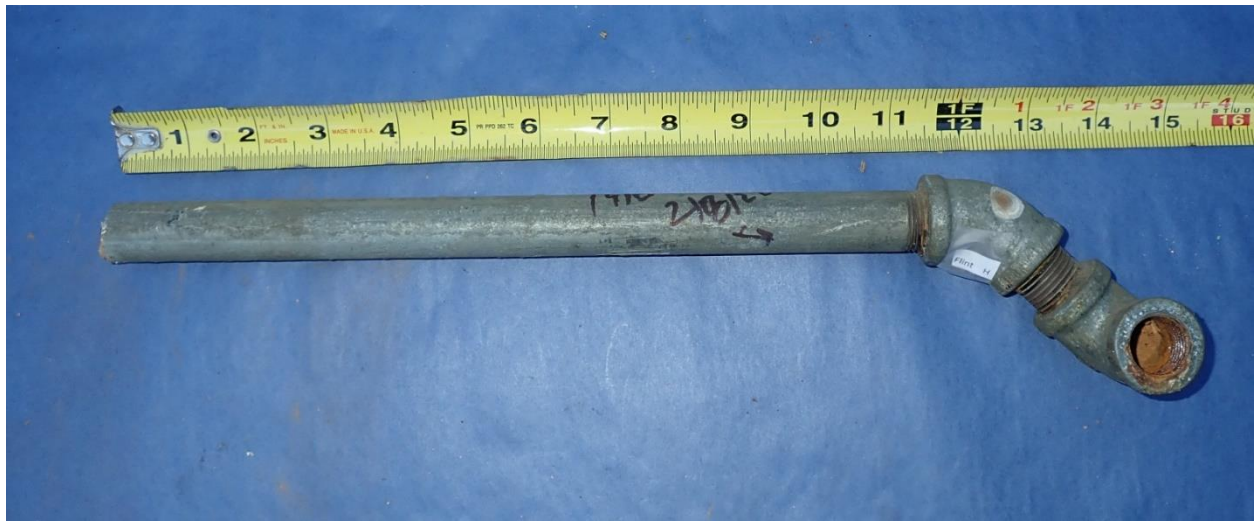
Figure 4.2-8: Pipe sample “H”. Note the corrosion and scale present (white spot) on the exterior of the elbow indicative of a through wall leak.

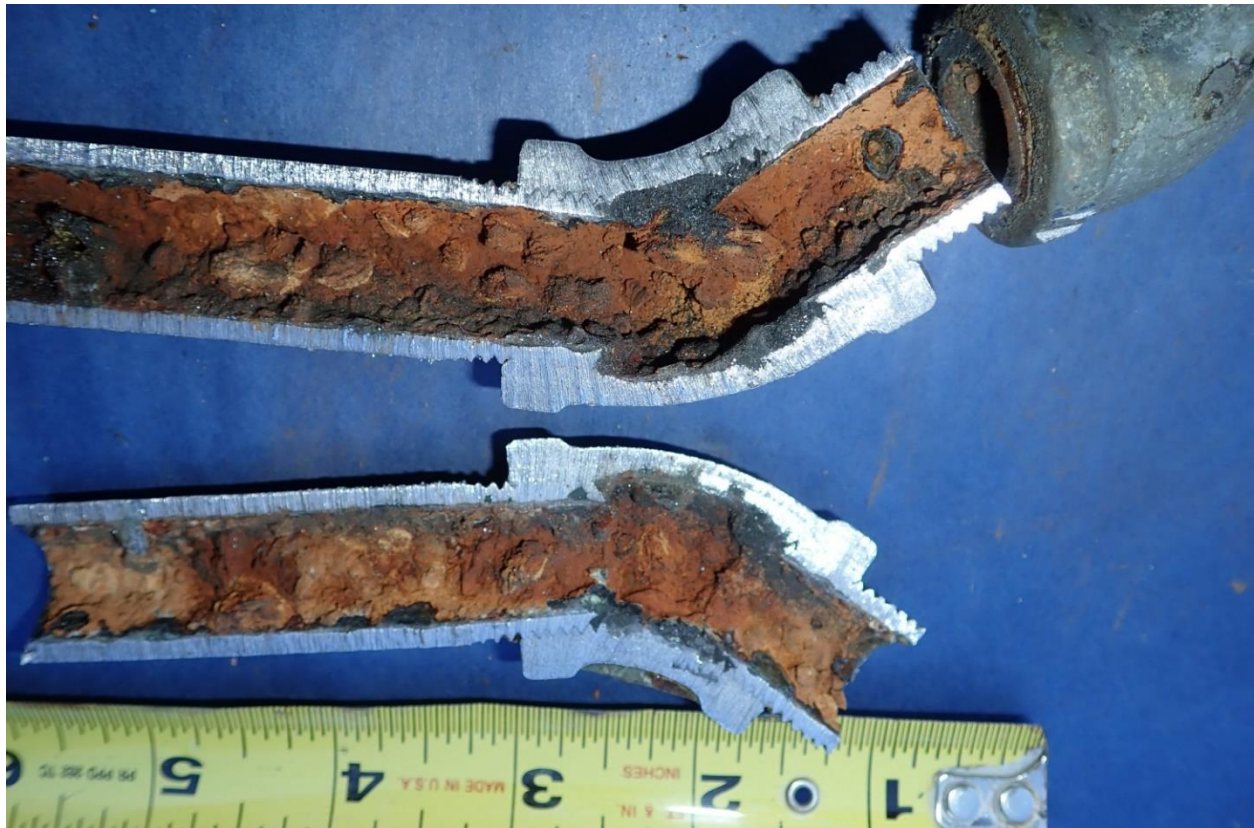
Figure 4.2-9: Pipe sample “H”, sectioned.

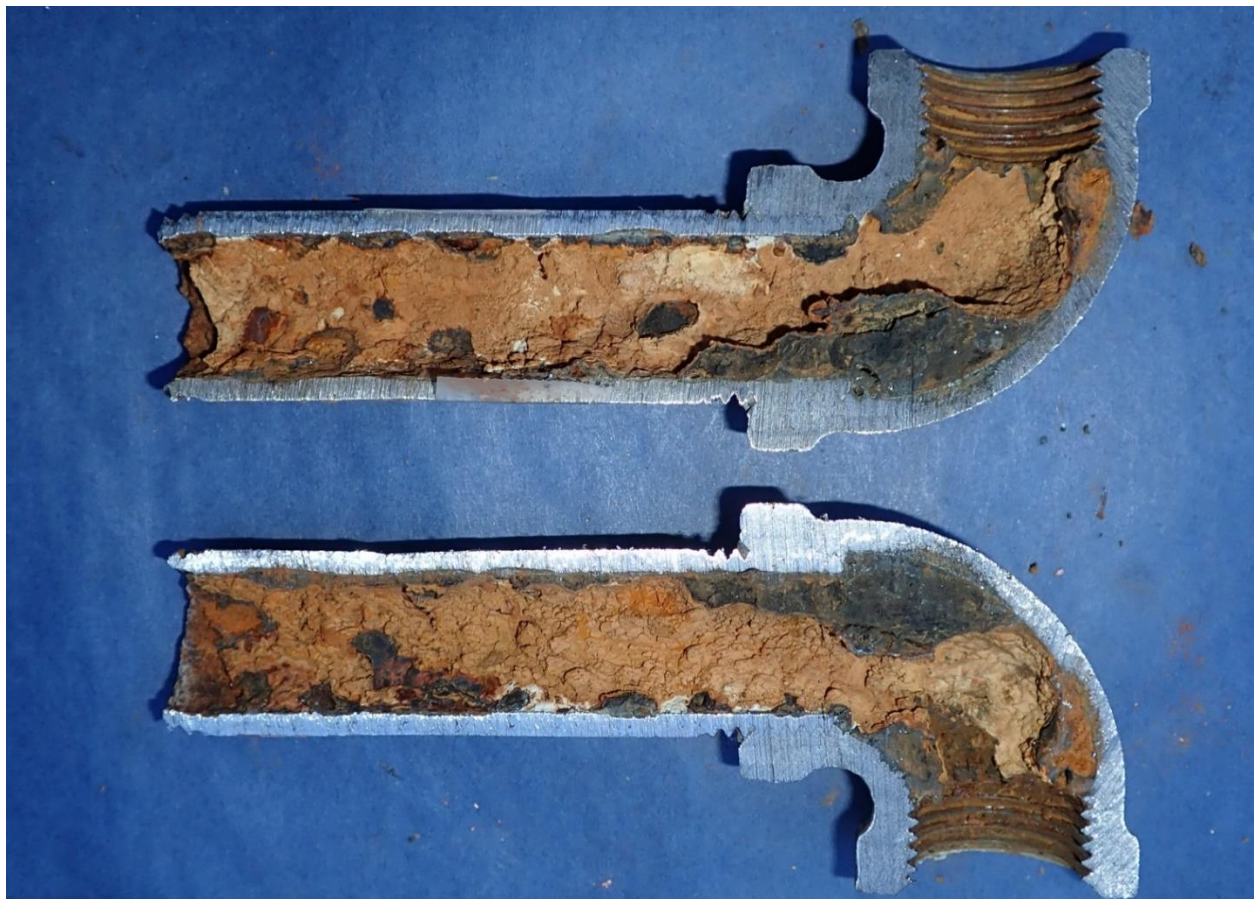
Figure 4.2-11: Pipe sample “I”, sectioned.
